A Guide for W-Beam Guardrail Damage Assessment (DRAFT)

A Field Manual for
Highway Maintenance Personnel

National Cooperative
Highway Research
Program
Project 22-28

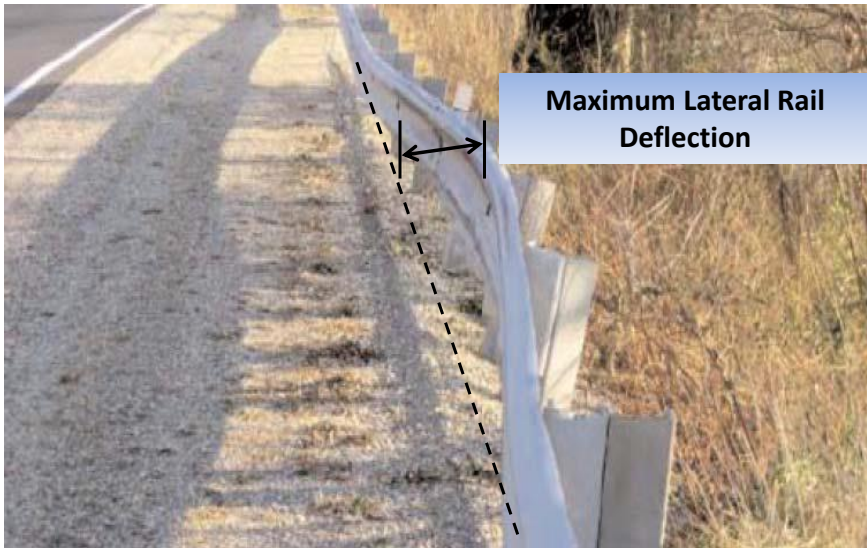
Lateral Rail Deflection

Maximum lateral deflection =	> 9 inches	High
	6 – 9 inches	Med
	< 6 inches	Low

Rail deflections exceeding 9 inches may significantly affect the ability of the guardrail system to contain and redirect vehicles. Beyond this critical deflection, the G4(2W) was shown to be susceptible to rail rupture, while the G4(1S) had an increased probability of overriding the barrier.

Rail deflections of 6 to 9 inches were found to compromise system performance, but the guardrail should function adequately under a majority of impacts.

At rail deflections less than 6 inches, the guardrail is expected to remain fully functional.

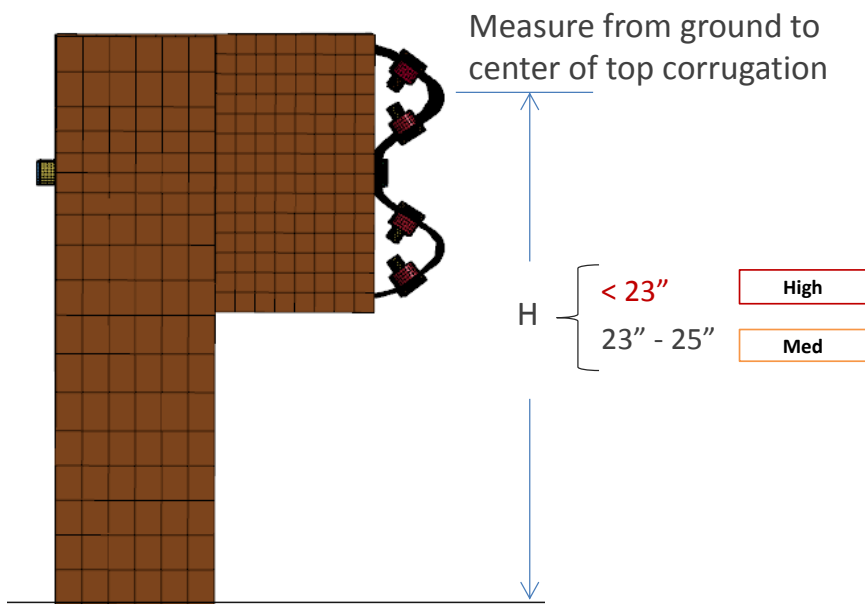
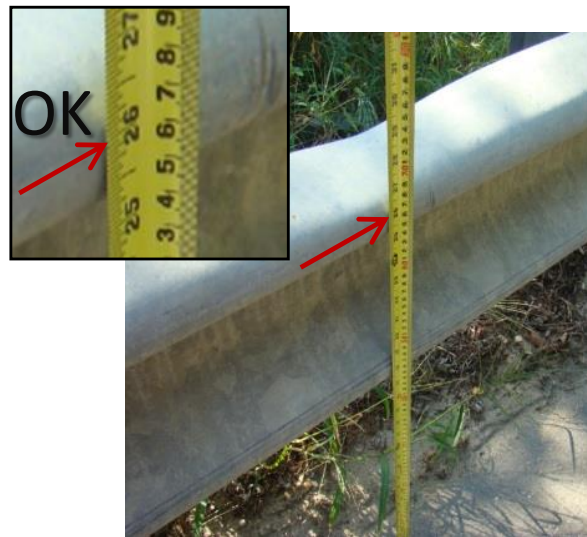
Rail Height Condition

Field Example

Rail height has traditionally been measured with respect to the top of the rail; however, for crash damaged guardrail it may be more appropriate to measure height with respect to the top corrugation of the rail. For example, a guardrail with standard top-of-rail height of $27\frac{3}{4}$ inch with a dent on the top of the rail that reduces (locally) the top-of-rail height by 4 inches may not significantly affect guardrail performance as long as the top corrugation is more than 23 inches above grade (also see Rail Crush criterion).

Analyses and full-scale tests have shown that there is a high probability for vaulting over the rail when rail height, as measured from the ground to the center of the top corrugation of the w-beam, is less than 23 inches. Therefore, when rail height, H , is less than 23 inches, the relative priority for repair is high.

Note that a top-of-rail height of $27\frac{3}{4}$ inches corresponds to $H=25\frac{1}{4}$ inches. Thus, based on the memorandum, when the rail height, H , is 23 to 25 inches, the relative priority for repair is classified as medium.

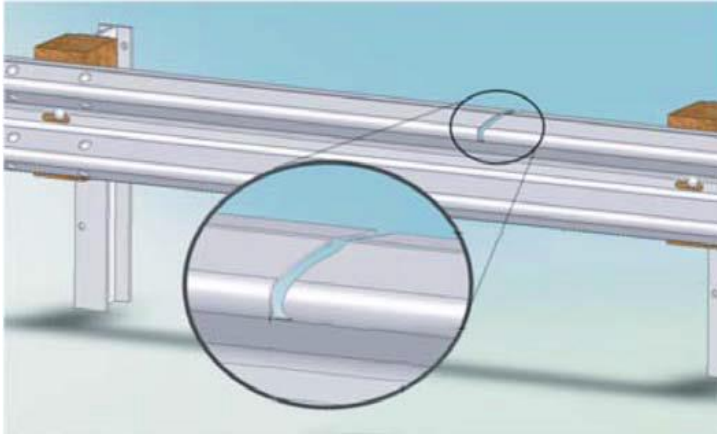
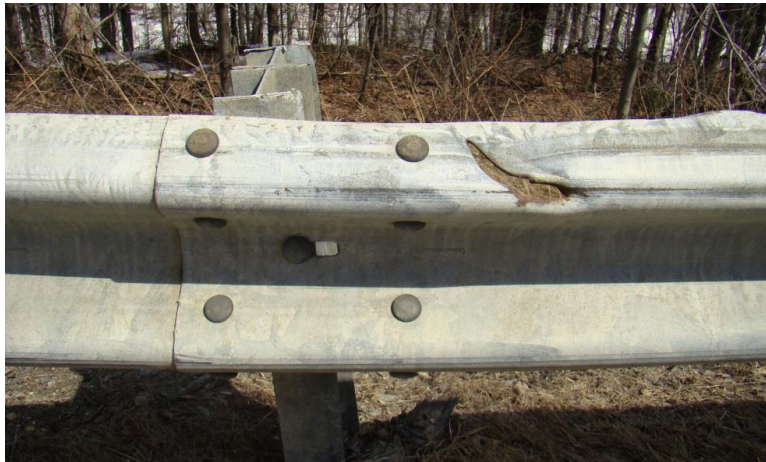
Vertical Tears

Any size vertical tear → **High**

Any vertical tear on a w-beam rail may significantly affect the ability of the guardrail system to contain and redirect vehicles. A vertical tear, particularly on or near the edge of the rail, has a high probability of propagating during impact and resulting in complete rupture of the rail. All vertical rail tears, therefore, indicate high priority for repair.

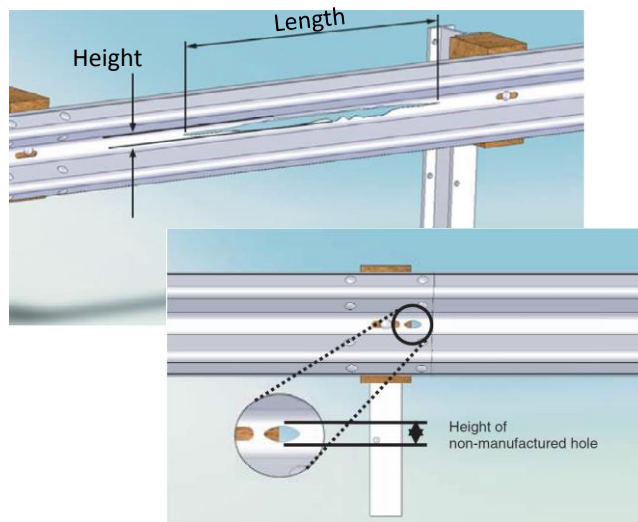
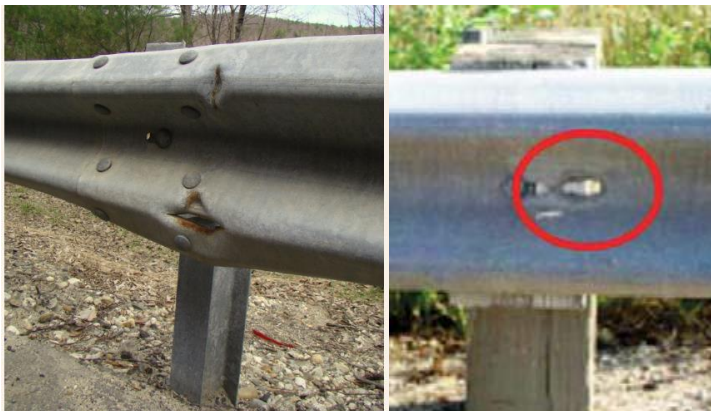
Rail Holes / Horizontal Tears

- Any size hole or tear at top or bottom edge
 - Hole with height > 1"
 - Three or more holes or tears on a panel
- High**
-
- 1 to 2 holes with height < 1"
 - Horz. Tears with Length > 12"
 - Horz. Tears with height 0.5 – 1"
- Med**

Any size hole or horizontal tear located at the top or bottom edge of the rail has the potential for causing a tear to propagate vertically and is therefore consider high priority for repair. Also, for holes with heights greater than 1 inch, or when there are three or more holes or horizontal tears on a w-beam panel, the relative priority for repair is classified as high.

For horizontal tears with lengths greater than 12 inches, or with heights between 0.5 – 1 inch, or when there are 1 to 2 holes with height less than 1 inch on a single panel, the performance of the guardrail may be compromised, but it should function adequately under a majority of impacts. Thus the relative priority for repair is classified as medium for those cases.

Pendulum tests have shown that horizontal tears located between the top and bottom corrugations of a w-beam rail do not notably reduce the tensile capacity of the rail. Such tears, however, can result in a part of the vehicle (e.g., front bumper) passing through the tear, exposing the component to direct impact against the guardrail posts; or further extending the tear as the vehicle progresses forward along the rail, increasing the potential for rail rupture. Engineering judgment should be used on a case by case basis when assessing horizontal tears with lengths greater than 12 inches.

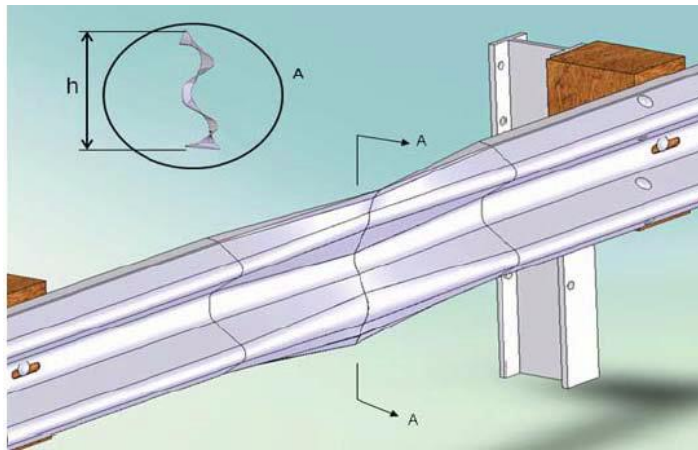
Rail Flattening and Rail Crush

Height of Rail Cross-Section, $h =$	$> 17''$	Med
	$9 - 17''$	Low
	$< 9''$	Med

For rail damage resulting in a cross-section height of 9 to 17 inches, the guardrail is expected to remain fully functional.

Note that the cross-section height of an undamaged w-beam rail is 12 inches.

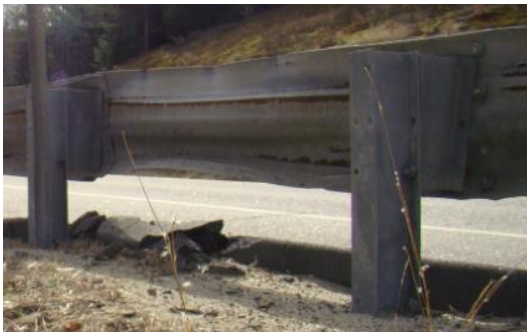
Field Example of
Rail Flattening

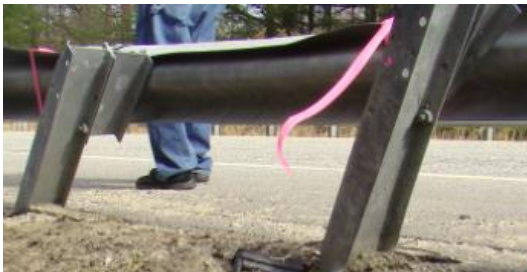
Field Example of
Rail Crush

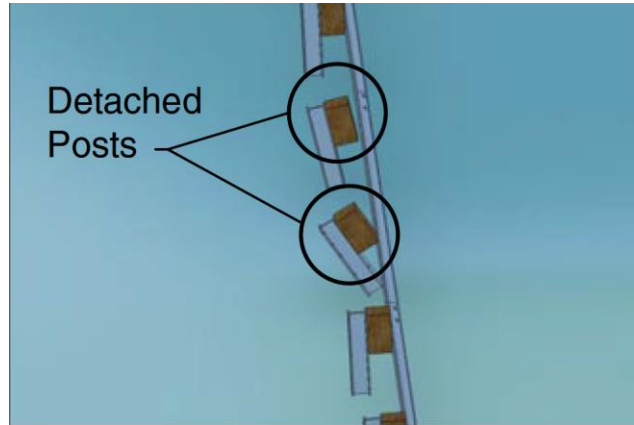
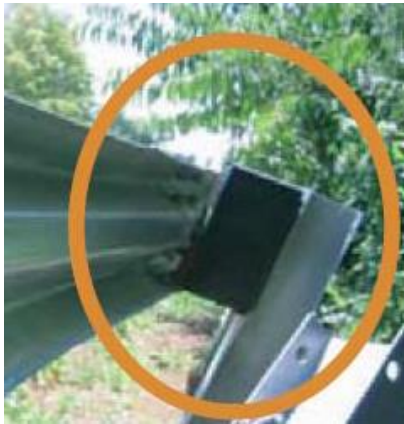
Posts Separated from Rail

- Post/rail separation > 3"
- 2 or more posts separated from rail

Field Example

For the case of a single post separated less than 3 inches from the rail, the system should remain fully functional. However, when two or more consecutive posts are separated, or when post/rail separation for a single post exceeds 3 inches, guardrail performance may be compromised. The relative priority for repair in such cases is generally medium; however, such damage often denotes the existence of other damage modes.

Post and rail separation rarely occurs without post and rail deflection or damage to other components. When post/rail separation greatly exceeds 3 inches or if multiple posts are separated from the rail, it is recommended that other aspects of the system be critically evaluated (e.g., lateral deflection, missing or damaged blockouts, etc.).

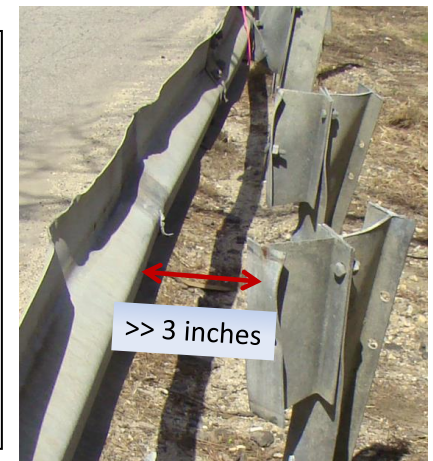
The photo shown to the right is an example of rail-post separation that warrants high priority for repair. Although the rail deflection is negligible, the extreme deformation and separation of the posts in this case render them nonfunctional.

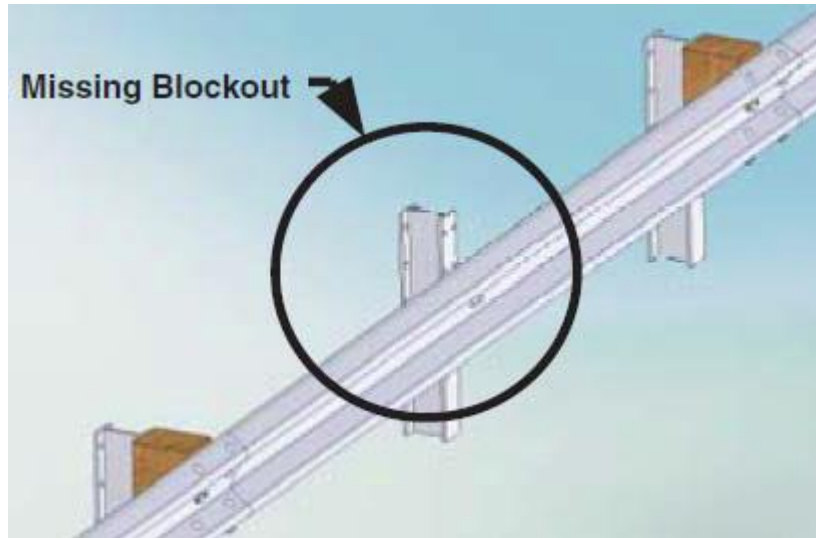
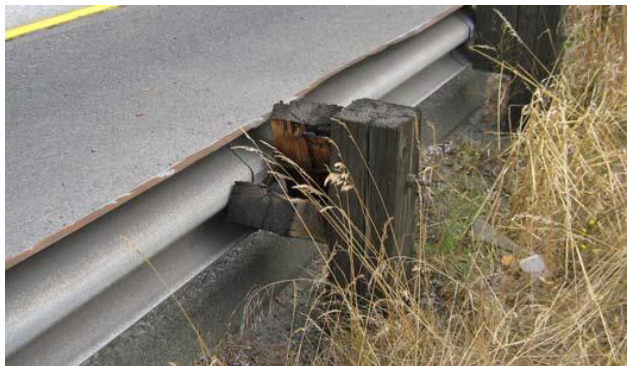
Blockout Condition

- Missing
- Cracked across grain
- Split through post hole
- Rotted

Field Example

This damage mode has not been shown to significantly affect guardrail performance; however, when one or more blockouts are missing, cracked across the grain, split vertically through the post-bolt hole or rotted, there is an increased potential for the rail to directly contact the posts during a collision, which may increase the propensity for rail tears (particularly for rail contact with steel wide-flange posts).

For this damage mode, the guardrail is expected to perform adequately for the majority of impact cases. The relative priority for repair is classified as medium.

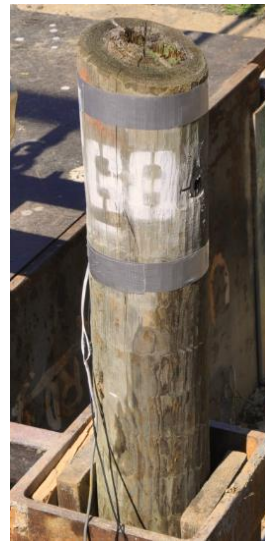
DL1

Force (k): 3.8 < 9
 Energy (k-in): 5.3 < 20
 Resi: 11.9 < 25

DL1: Generally there is no deterioration evident at the top of the post. In some cases, however, signs of deterioration may exist near the top-center of post, but will not extend to the outer shell. The post is relatively sound when struck with a hammer.

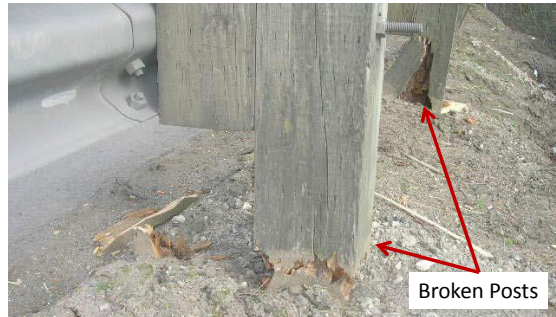
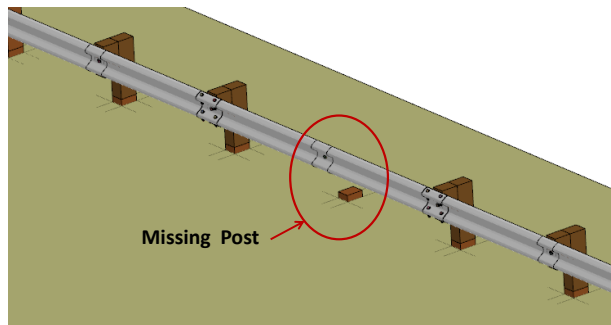
Missing / Broken:

High

If any posts are missing, broken or cracked across the grain the guardrail will not function properly and should be repaired. Also, any posts with deterioration level 3 (DL3) are essentially non-functional and are considered to be of high priority for replacement.

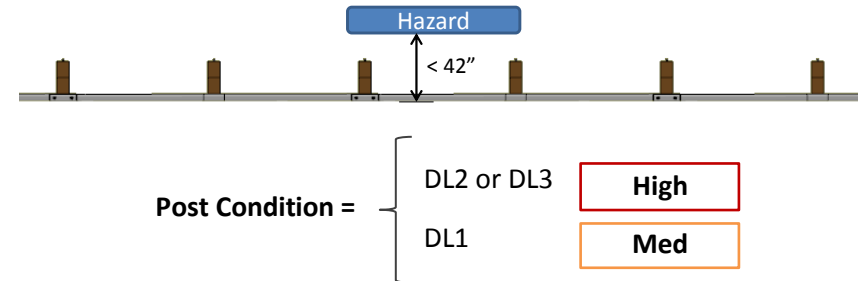
If hazard is located less than 42" behind face of rail:

When a fixed/rigid hazard is located within 42 inches behind the guardrail, then posts with damage level DL2 or greater should be replaced with high priority, due to potential for large rail deflection leading to vehicle contact with the hazard.

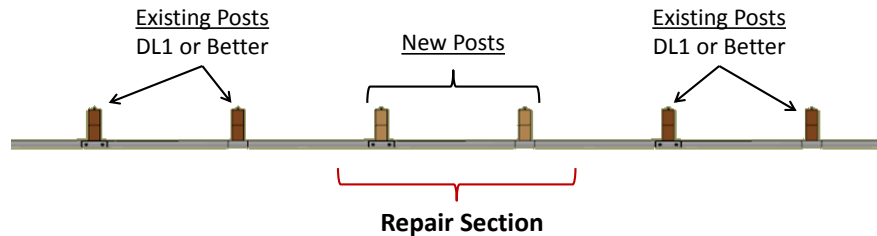
If posts adjacent to the repair section are DL1 or better:

If the adjacent posts are DL1 or better then only the posts in the damage region need to be replaced.

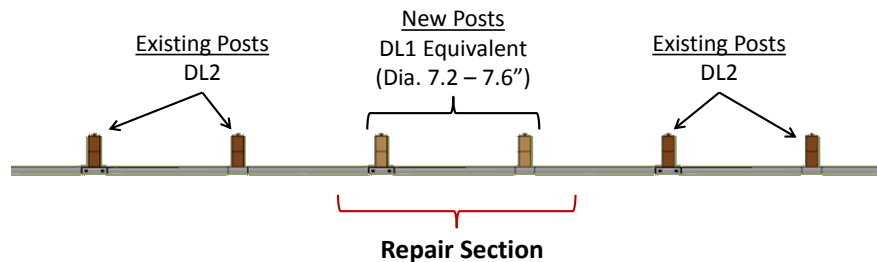
If posts adjacent to the repair section are DL2:

If the adjacent posts are DL2, then either: (1) all posts in the system should be replaced with new posts or (2) the damaged posts in the immediate repair section should be replaced with posts of equivalent strength to DL1 (e.g., new posts with reduced cross-section). From available test data, new round posts with a diameter of 7.2 to 7.6 inches meet this condition. Moreover, these reduced post diameters also meet the minimum size criteria for round posts (i.e., 8 ± 1 inches).

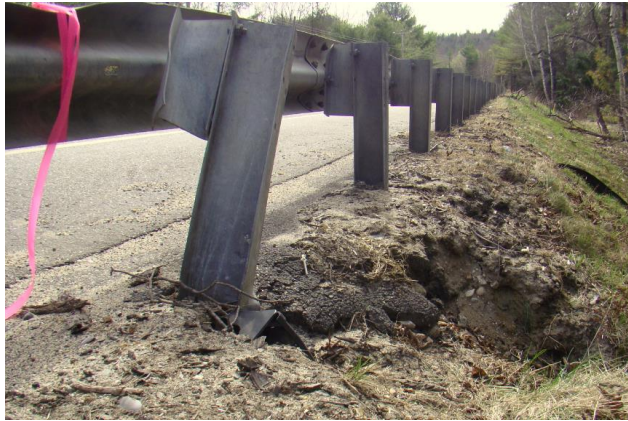
Erosion at a Single Post within a Four-Post Span:

Erosion =	$\geq 12''$	High
	9 - 12''	Med

Erosion depth of 12 inches or greater around the post indicates high priority for repair due to increased potential for excessive pocketing and rail rupture.

Erosion depths of 9 to 12 inches were found to compromise system performance, but the guardrail should function adequately under a majority of impacts. This damage level is classified as medium.

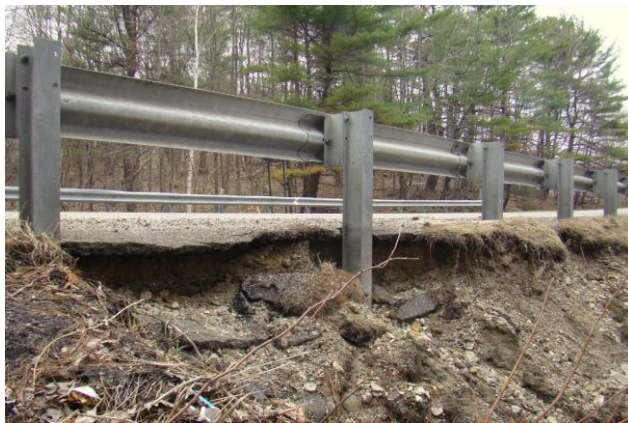
Erosion at Multiple Posts within a Four-Post Span:

Erosion =	$\geq 6''$	High
	4 - 6''	Med

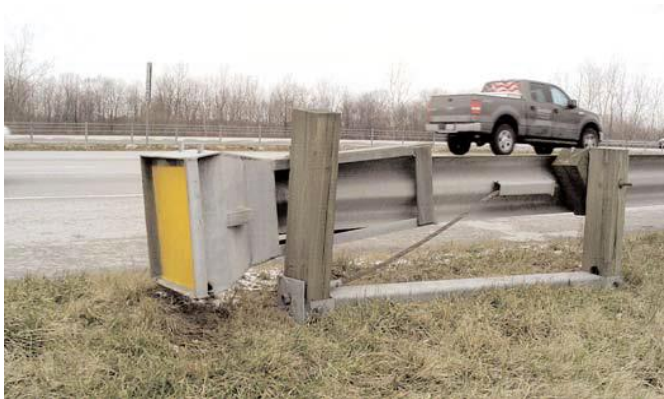
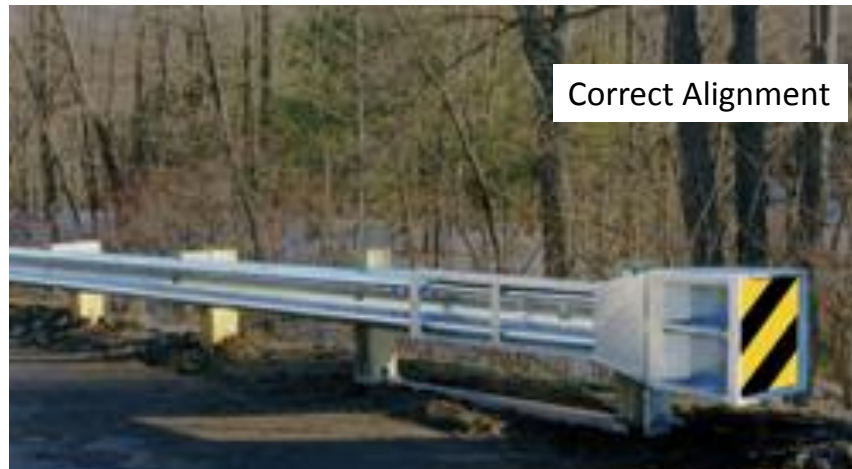
Impact Head

Misaligned or missing screws:

Note: Attachment hardware for the impact head will vary depending on manufacturer.

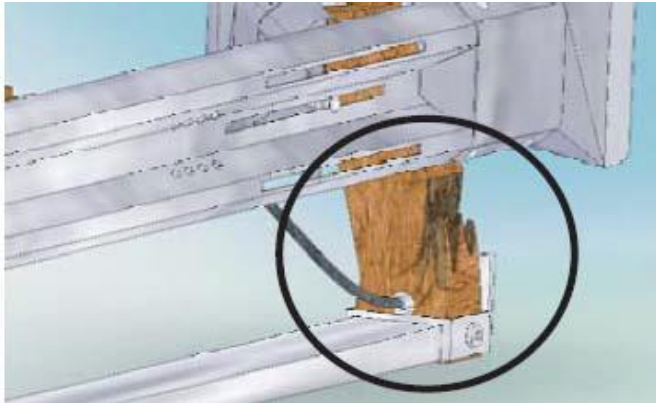
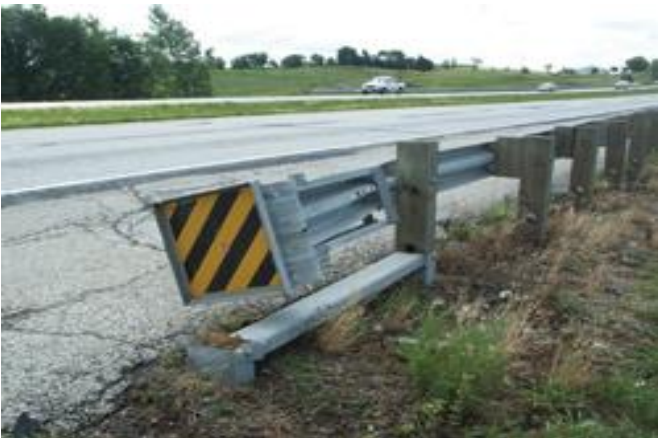
Damaged End-Post

Damaged, Severely Cracked, Rotted or Missing End-Post:

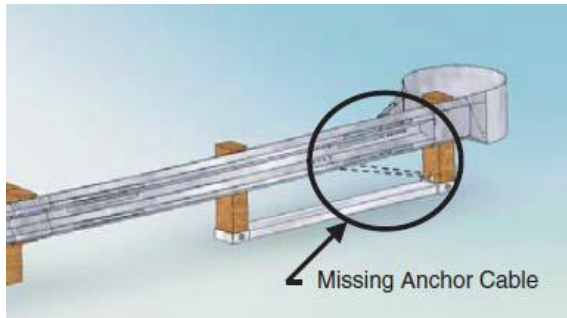
Missing Cable:

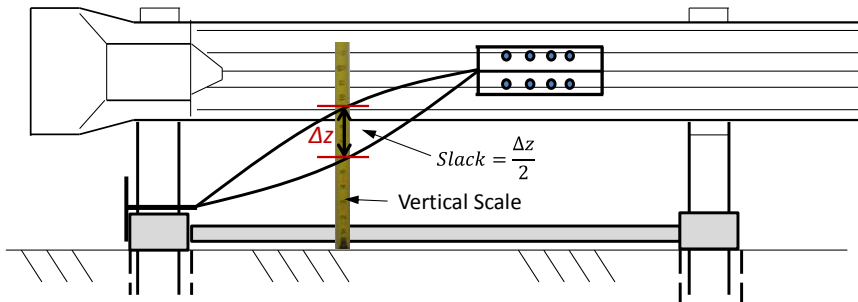
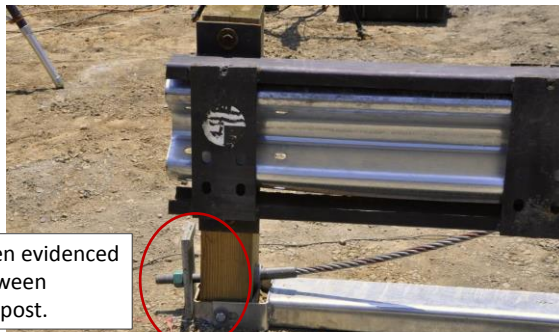
Loose Cable:

$$Slack = \frac{\Delta z}{2} = \begin{cases} >3 & \text{High} \\ 2-3 & \text{Med} \end{cases}$$

Loose cable is often evidenced by separation between bearing plate and post.

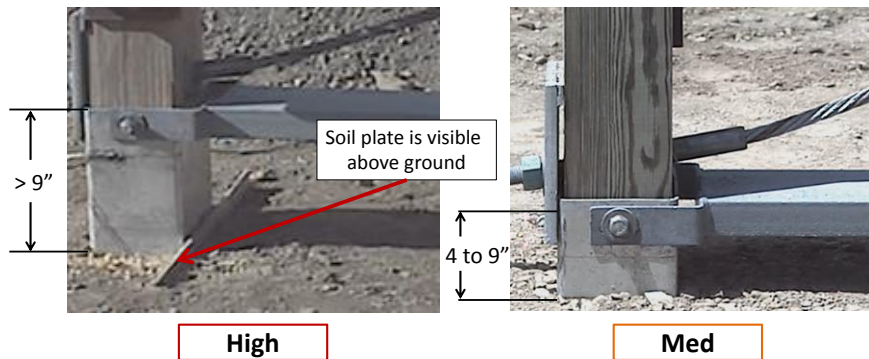
Stub Height:

$$\text{Stub Height} = \begin{cases} > 9" & \text{High} \\ 4-9" & \text{Med} \end{cases}$$
